Blackjack 24 RTR Radio Tray Addendum

Products: PRB Blackjack 24™ (PRB08007)

Issue: Some boats may have loose radio trays.

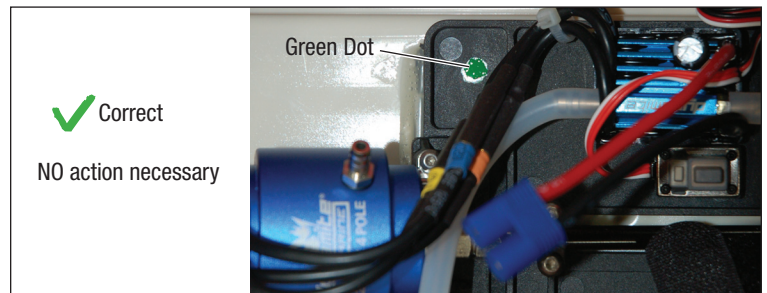
What to Do: Inspected radio trays are marked with a green dot as shown in this photo and are correct. If there is no inspection mark, check to make sure the radio tray is firmly attached to the hull.
Contact Horizon Hobby Product Support if you have any questions.

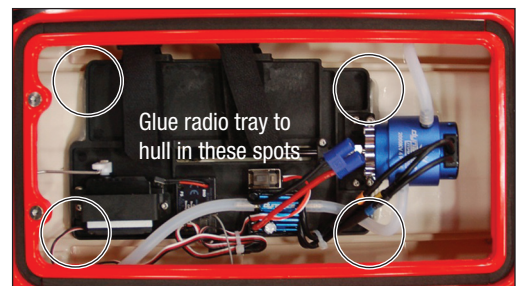
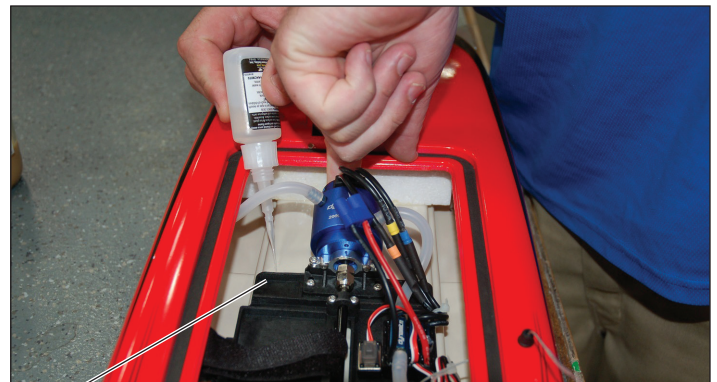
1. Pulling on the battery straps may loosen the radio tray from the hull.
2. If the radio tray becomes loose, apply CA (cyanoacrylate adhesive) between the tray and the hull as shown in these photos.

Carefully lift the radio tray up and apply CA between the tray and Hull

IMPORTANT: The motor is connected to the shaft, holding the tray in the hull. Carefully lift the tray while applying adhesive.
